MANDATORY BULLETIN No. EV 97 – 012 a

1. **CONCERNING TO:** All **EV-97 Eurostar** aeroplanes manufactured and delivered till 15.7.2009.
2. **REASON:** It was found a play of the rudder on one of the EV-97 Eurostars in operation.
The cause was loose upper hinge of the rudder due to improper securing of the nut against loosening, see Appendix 1.

Appendix 1 – Loose upper hinge of the rudder

Appendix 2 – Procedure to modify nut securing of the rudder upper hinge

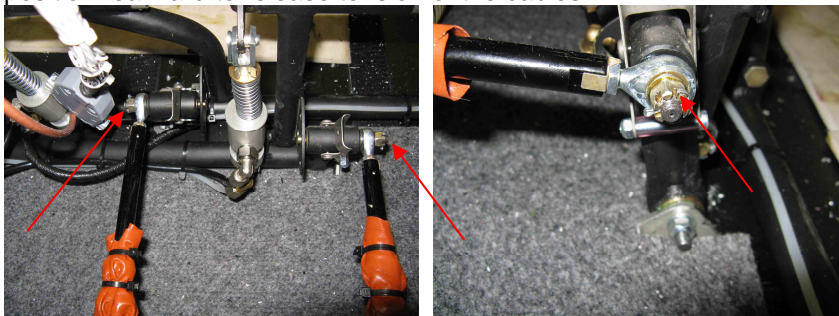
1. Release tension of the rudder cables (without doing this the cables will be dragged into the fuselage after being disconnected from the rudder). Draw a cotter pin out of the castle nut at the nose wheel control rod attachment to the rudder pedals. Then use M9 nut wrench to unscrew the castle nut. Do this on both control rods. Disconnect nose wheel control rods from the rudder pedals. Adjust pedals position rearward to release tension of the cables.

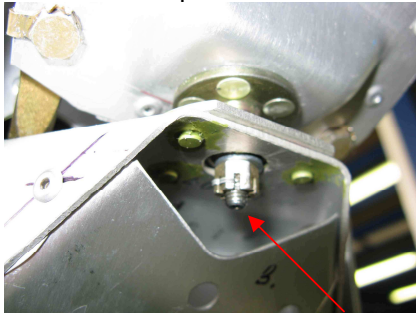
2. Use a suitable pliers to draw a cotter pin out of the castle nut securing rudder lower hinge.

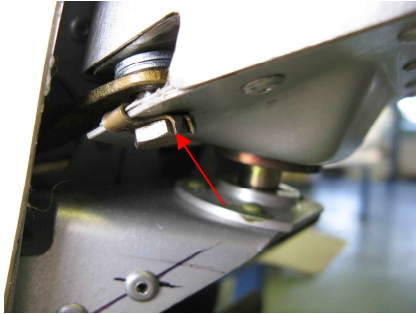
4. Use a suitable tool (flat screwdriver) to straighten up the tabs of the tab washers under the screws which attach control cables to the rudder bottom.

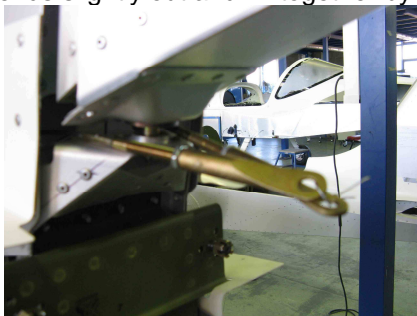
5. Use M9 nut wrench to unscrew both screws attaching the cables to the rudder and pull the cable ends slightly out and fix together by a wire, so that to not be drawn into the fuselage.

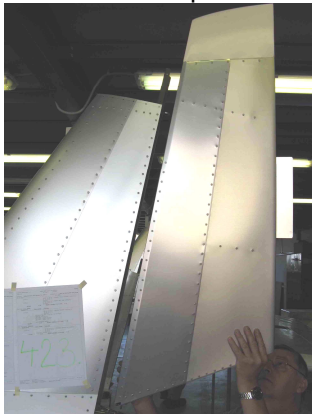
6. Lift the rudder up and remove from the fin.

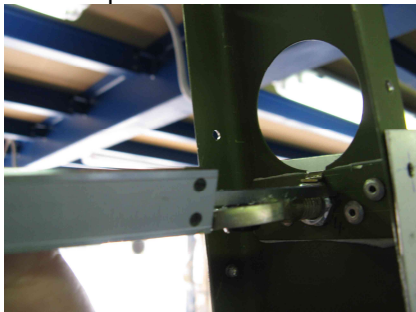
7. Use a slide calliper or another suitable rule to measure distance of the hinge eye rear edge from the fin rear spar and note this value.

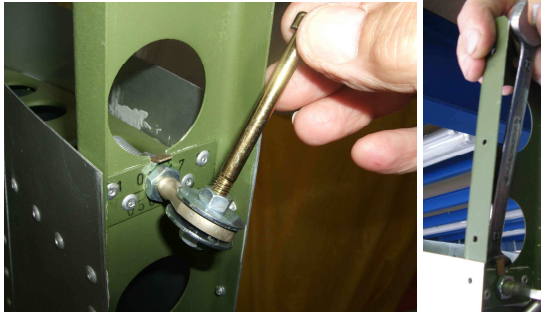
8. Screw M6 nut on a sufficiently long M6 bolt (80 mm), then put a washer (25 mm diam.) on the bolt and insert into the hinge from above. Put another washer on the bolt from below and tighten with another M6 nut. Now set M13 nut wrench through a lightening hole on the self locking nut inside the fin (right figure below) and turn the M6 bolt to release and unscrew the hinge.

Take care at the end, so that the self locking nut and washer do not fall down into the fuselage.

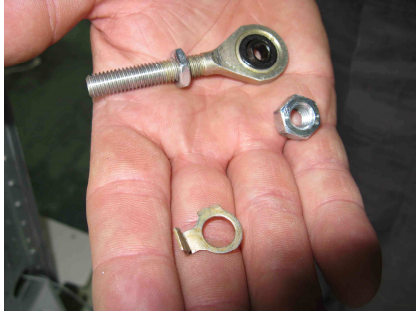
9. Pull out the hinge, self locking nut and tab washer

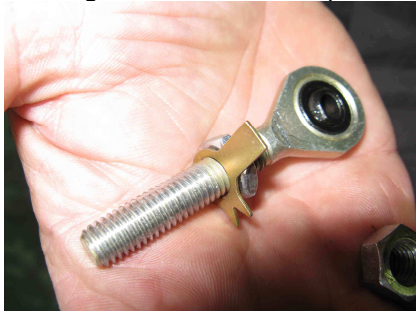
10. Set a new tab washer (size 8) onto the hinge thread. It is not recommended to straighten up and use original washer, due to possible cracking when being bent repeatedly.

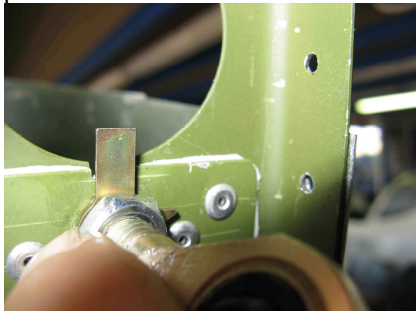
11. Set the hinge back on the fin spar, the washer must be on the outside of the spar as shown on the picture.

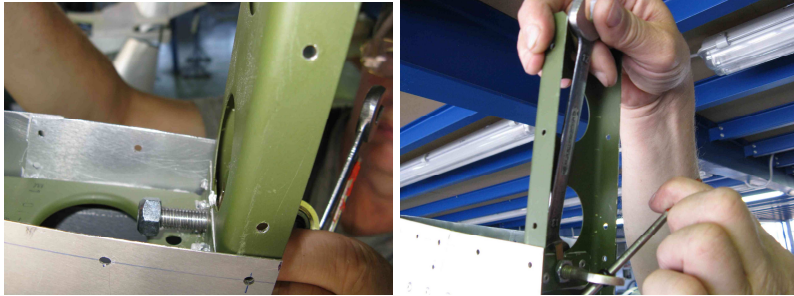
12. Screw the self locking nut (it has steel core so can be re-used) and turn it several times to be fixed on hinge thread. Then follow step 8 to install M6 bolt, washers, and nuts. Turn the bolt clockwise to screw down the hinge eye.

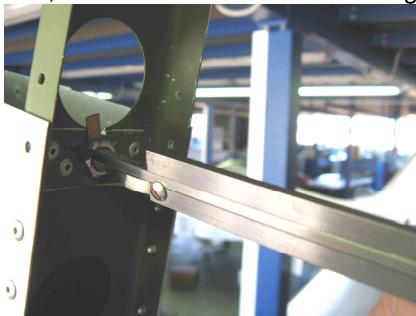
13. Measure the distance between hinge eye rear edge and fin spar and if different from the original one, then screw or release the hinge to adjust this distance.

14. When the distance is adjusted tight the nut by M13 nut wrench.

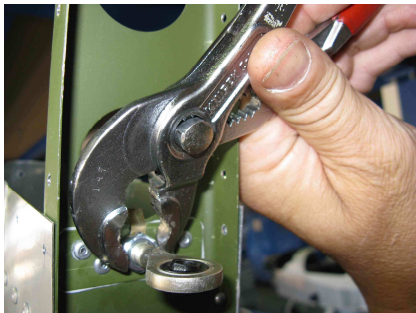
15. Use suitable tools (screwdriver and pliers) to bend tabs of the washer to secure the nut against release.

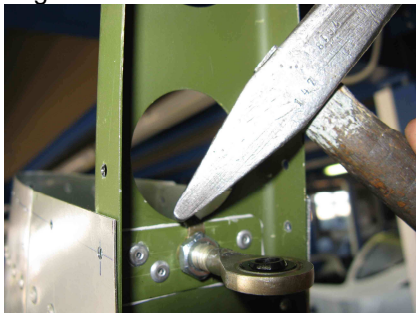
16. The washer bigger tab must be bent forward by a suitable tool (e.g. flat screwdriver and hammer) to protect the washer from rotation. The end of bigger tab should be pressed up to the self-locking nut edges.

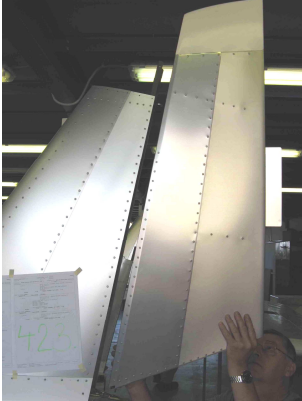
17. Set the rudder back onto the hinges.

18. Re-install the castle nut back on the rudder lower hinge, tight with M13 nut wrench and secure by the cotter pin.

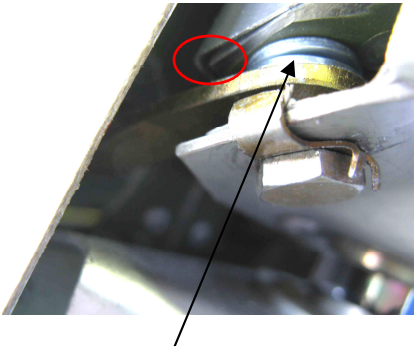
19. Set new tab washers (size 6) on the cable attachment screws.
20. Re-connect the cables and screw down the screw. Secure screw heads against release by bending the washer tabs.

Note: The two „normal“ washers above the cable ends are installed to prevent cables from being chafed from the rudder front lower edge (marked red). Installation of these washers is recommended if not installed and there is an evidence of chafing in this area.

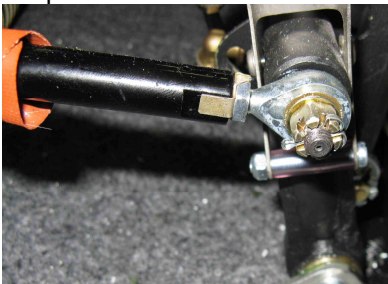
21. Set the rudder pedals back to their original position and re-connect the nose wheel control rods to the pedals. Install castle nuts and secure by the cotter pins.
